TROUBLESHOOTER

LEADING TECHNICAL INFORMATION SUPPLIER AUTODATA SHARES FIXES TO THREE COMMON PROBLEMS FOUND IN MODERN MOTOR VEHICLES.

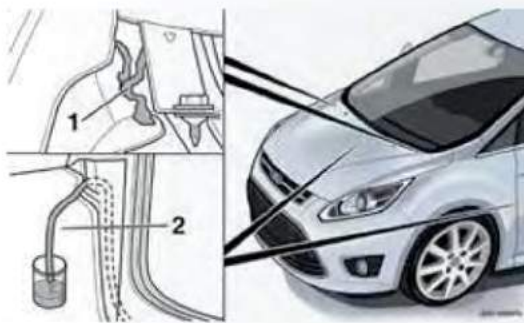
Ford C-Max

WATER INGRESS

Question: We are experiencing a problem identifying water ingress on a 2010 Ford C-Max. The front carpets are getting wet, resulting in condensation on the windows. We have carried out exhaustive tests but can't see how the water is getting in. Can you help?

Answer: We are aware of this problem, which is caused by water entering the vehicle via the lower bodywork joint at the A-post (Fig 1.1). Remove the side trim panels in the RH and LH footwells. Using a suitable extraction tool remove any residual water from the A-post (Fig 1.2). Seal the lower bodywork joint at the A-post with a proprietary body sealant. When the sealant has dried, paint the sealant to match vehicle body colour. Ensure the carpets are thoroughly dried out.

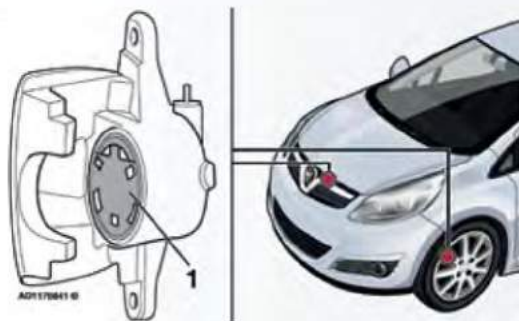
BRAKE NOISE

Question: We look after a 2007 Vauxhall Corsa 1,2 and are having a problem with brake noise. The car has only done low mileage so the brake discs are in very good condition and we have cleaned the front brake pads twice now in an attempt to stop the brakes squealing. But the customer is now complaining of the problem again, do you know of any issues with this model?

Answer: The issue of front brake squeal during normal braking has been noted before. The problem has been solved by fitting a new design of the front brake pad kit, which now includes a shim that fits between the brake caliper piston and the brake pad (Fig 1.1). Two new front brake pad kits, one for 12mm thick brake discs and one for 22mm brake thick discs, are available from your local Vauxhall dealer. Fitting the modified brake pads and shims should fix the problem.

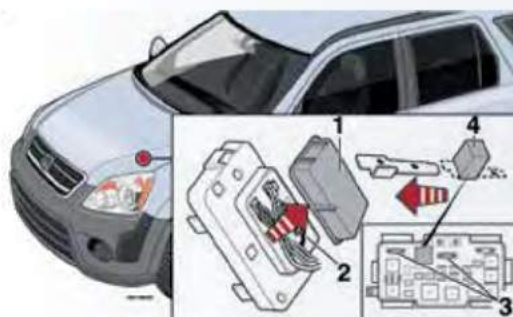
ELECTRICAL PROBLEMS

Question: We are experiencing a problem with a 2004 Honda CR-V 2,2 i-CTDi. It is illuminating the engine check lamp and storing trouble code P1298 (electrical load sensor – voltage high). We have checked the vehicle wiring but as we can't find any sensor on the battery we suspect it may be an engine control module problem. Can you help?

Answer: The electrical load sensor is located in the engine bay fuse box/relay plate and has suffered a problem with a faulty soldered joint. This problem also affects some Honda Civics made between 2001 and 2005. Disconnect the battery, remove the fuse/relay plate lower cover (Fig 1.1) and disconnect the three pin multi-plug (Fig 1.2). Remove the two fuses (Fig 1.3) and the electrical load sensor (Fig 1.4). Replace the electrical load sensor and refit components in reverse order of removal. Reconnect the battery and delete the trouble code. Start the engine and run to obtain normal operating temperature. Allow engine to idle for 10 minutes with all electrical load switched off. Carry out battery reconnection reset procedures to reset memory functions.
