TROUBLESHOOTER

LEADING TECHNICAL INFORMATION SUPPLIER AUTODATA SHARES FIXES TO THREE COMMON PROBLEMS FOUND IN MODERN MOTOR VEHICLES.

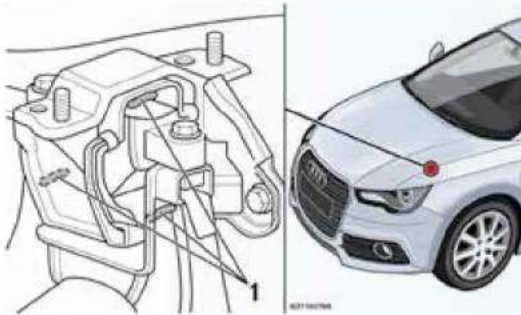
Audi A1 1.6 TDI

ENGINE COMPARTMENT NOISE

Question: We are having trouble finding the cause of a squeaking/rubbing noise from the engine compartment when pulling away or driving over uneven surfaces on a 2011 Audi A1 1.6 TDI. We have visually checked all of the steering and suspension components and checked that the engine mounting bolts are tight.

Answer: We are aware of this problem that is caused by excessive friction between the LH upper gearbox mounting rubber and mounting body. Access the gearbox mounting, slacken the mounting bolts and apply a small amount of silicon grease to the areas where rubber and metal are in contact (see Fig. 1). Retighten the gearbox mounting bolts and carry out a road test to confirm the noise is no longer present.

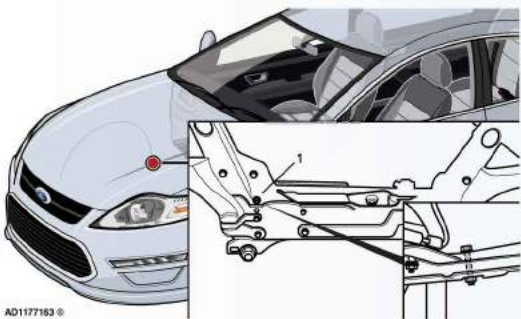
CREAKING NOISE FROM FRONT SUSPENSION

Question: We are having trouble finding the cause of a creaking noise from the front suspension when driving over uneven surfaces in a 2012 Ford Mondeo 2.2 TDCi. We have checked all the suspension components for wear and play. We have also made sure all the bolts for the front suspension and front subframe are tight and still the noise persists.

Answer: The problem you are describing affects all Mondeo, S-Max and Galaxy models from 2012-2013, excluding models fitted with the 2.0 EcoBoost engine. The cause of this creaking noise is excessive friction between the front subframe sections. Fit an additional nut and bolt available to the RH side of the front subframe to clamp the subframe sections together, then tighten the nut to 110Nm (see Fig. 1). Road test the vehicle, this should solve the problem.

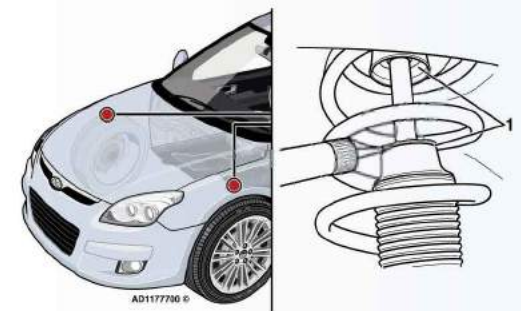
Hyundai i30

ABNORMAL NOISE FROM FRONT SUSPENSION

Question: We are having difficulty finding the source of an abnormal noise from the front suspension on a customer's 2009 Hyundai i30. We have checked all of the suspension components but can't find any excessive wear. Are you aware of this problem?

Answer: Yes, this has been reported by other i30 owners and affects models from the start of production up to 31/05/2010. The problem is due to movement between the front shock absorber damper rod cover and the front suspension upper mounting bush. Pull down the shock absorber damper rod cover and thoroughly clean the damper rod cover top and upper mounting bush (see Fig. 1). Apply an appropriate sealant to the upper outside edge of the shock absorber damper rod cover and refit. Carry this procedure out on both front shock absorber damper rod covers. Road test the vehicle to confirm the noise is no longer present.
