TROUBLESHOOTER

LEADING TECHNICAL INFORMATION SUPPLIER AUTODATA SHARES FIXES TO THREE COMMON PROBLEMS FOUND IN MODERN MOTOR VEHICLES.

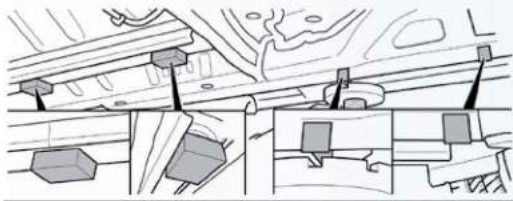
AD1180428 ©

MERCEDES A-CLASS

RATTLING NOISE FROM UNDERSIDE OF CAR AT HIGH SPEED

Question: We are struggling to diagnose a 2012 Mercedes A-Class with a rattling noise from the floor area of the car at motorway speeds. We have heard the noise but cannot pinpoint the cause in the workshop. Are you aware of this noise?

Answer: We are aware of this concern affecting the A-Class (176) and GLA (156). The rattling noise is due to the underbody shields vibrating against the underside of the vehicle. Foam pads and insulation strips are available from the Mercedes-Benz parts department. Remove the underbody shields, fit foam pads to the underside of the vehicle on the left hand side along with the insulation strips. Repeat procedure for right hand side, refit the underbody shields and then carry out a road test to ensure noise is no longer present.

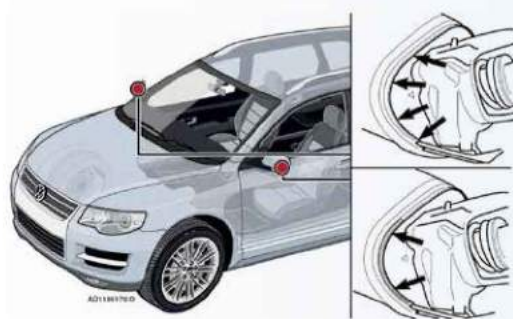
AD1189176 ©

VOLKSWAGEN TOUAREG

WIND NOISE

Question: We are having trouble finding the cause of wind noise on a 2009 Volkswagen Touareg. We have heard the noise on a road test but we are unable to locate the problem in the workshop. Has anyone reported this noise before?

Answer: This fault is known to us and affects Touareg models 2008–2009 models. The cause of the wind noise is due to an unsatisfactory design of the door mirror cover. Remove the door mirror cover, thoroughly clean area on door mirror mounting, then apply a length of butyl tape (approximately 80mm) to the door mirror mounting. Refit the door mirror cover. Road test the vehicle to ensure the wind noise has gone.

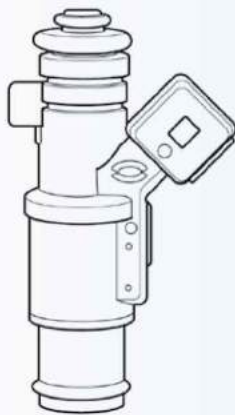
AD1191286 ©

CITROEN C3

ENGINE WARNING LAMP ILLUMINATED AND RUNNING PROBLEMS

Question: We are experiencing a problem on a 2005 Citroen C3 1,4. A few months ago we replaced a fuel injector due to the following symptoms: illuminated engine warning lamp, fuel injector trouble codes, engine cutting out and engine running on three cylinders. The vehicle has come back with the same symptoms present as before. Have we missed the root cause of the problem somewhere?

Answer: This issue is known on the C3 I/II with engine codes HFX (TU1A), KFV (TU3A) and KFV (TU3JP). The cause of the symptoms you have described is due to water ingress into the injectors causing corrosion. This water ingress is caused by faulty windscreen washer jets. Replace the windscreen washer jets with modified ones available from Citroen parts department, inspect the injectors and replace with modified ones if necessary. Modified injectors can be recognised by a white silicone cap. Access ECM fault memory and erase troubles codes. Road test the vehicle to confirm the fault has been rectified.
